Assessing, remediating and performance monitoring abandoned mine sites in the Northwest Territories

By Reid Smith and Arlen Foster

The Bullmoose Area mine sites remediation and monitoring project encompasses the assessment, remediation, and performance monitoring at seven abandoned mine sites (Ruth, Bullmoose, Beaulieu, Spectrum, Chipp, Storm, and Joon) located between 70 and 90 kilometres east of Yellowknife.

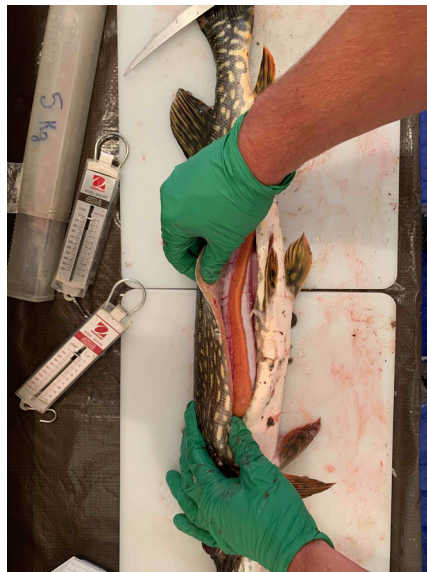
Fish health field dissection of a Northern Pike.

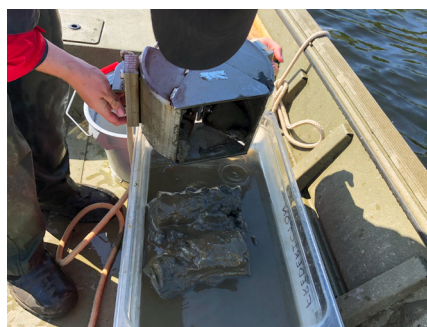
Lake sediment sampling as part of the Aquatic Effects Monitoring Program.

Results indicated that concentrations of contaminants in water and sediment within Bullmoose Lake and the reference lake were generally below Canadian Water Quality Guidelines for Protection of Aquatic Life and Canadian Sediment Quality Guidelines Probable Effects Levels. Comparisons in abundance of targeted fish, fish health and tissue chemistry between Bullmoose Lake and the reference lake did not identify differences due to suspected effects of historical mining.
